KOOTENAI DEVELOPMENT IMPOUNDMENT DAM

FEBRUARY 2011 ROUTINE OWNERS INSPECTION

Prepared by: Kurt Hafferman, P.E.

Inspection Date: March 04th, 2011

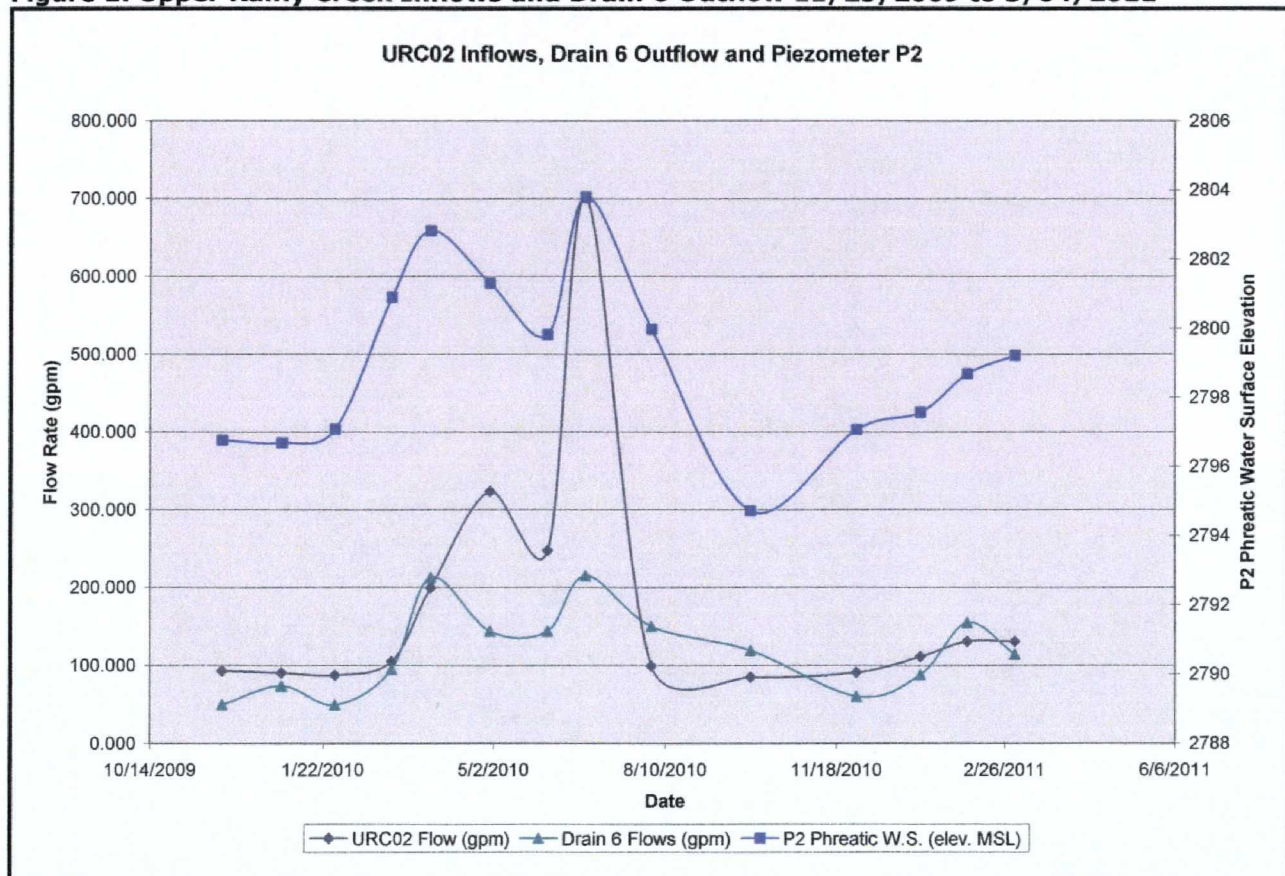
Figure 1: Upper Rainy Creek Inflows and Drain 6 Outflow 11/25/2009 to 3/04/2011

Drain 6, the main drain at the toe, decreased flow. The decrease was from 154.64 gpm to 114.2 gpm, a decrease of 40.44 gpm, or 26.1% since the February inspection. This indicates that flows are finally stabilizing in the reservoir after multiple rain-on-snow and snowmelt events this year resulted in increased flows in recent months. The drain flows recorded are slightly higher than the same time last year, which correlates with the increase in precipitation so far this year. A graph of the Rainy Creek inflows and drain 6 outflows from November 25th of 2009 to this inspection is shown in Figure 1 below.

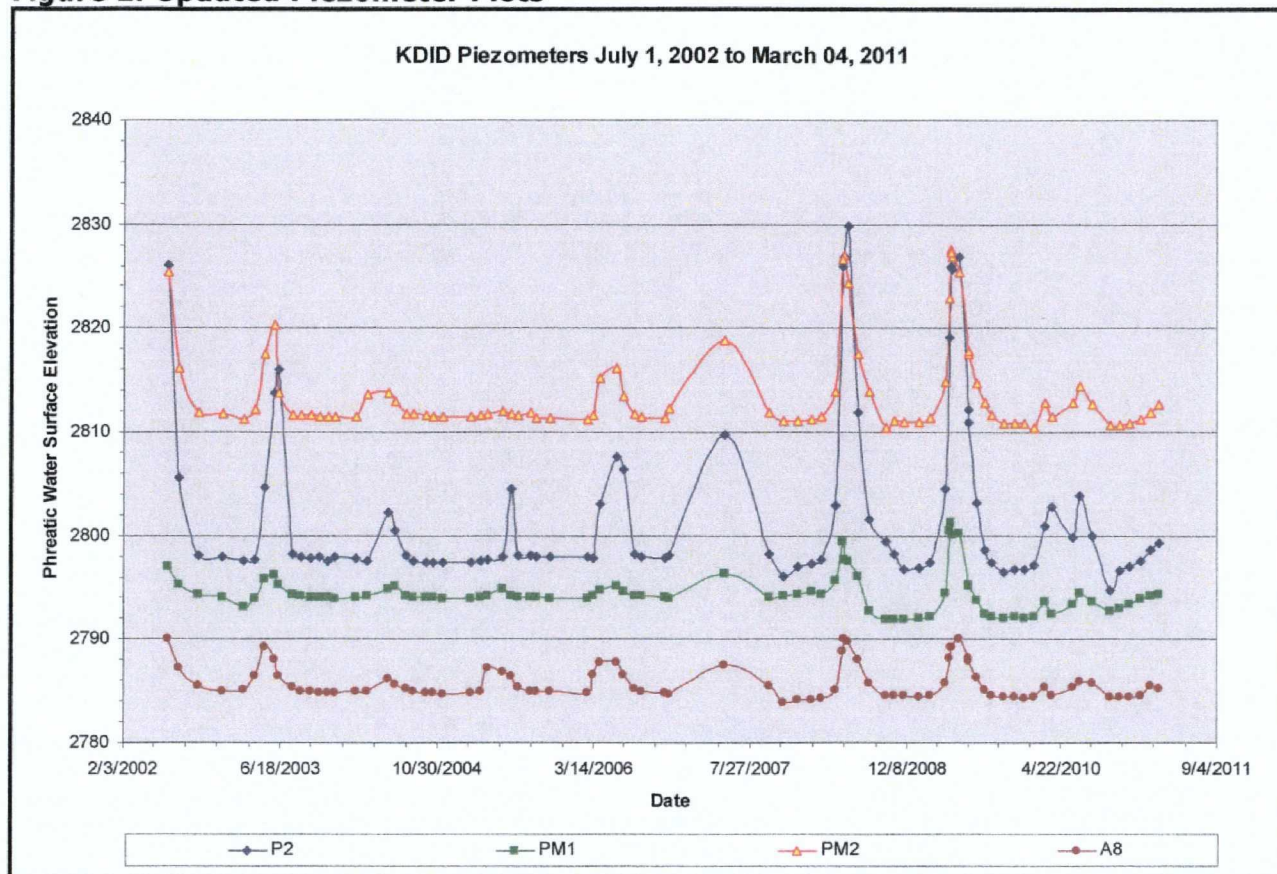
Figure 2: Updated Piezometer Plots

The updated piezometer data is shown in Figure 2 below. It was noted that piezometer readings are still rising with the exception of piezometer A8 which is stable to slightly falling. This has been unusual as we typically have declining inflows and piezometer readings until late February to early April in most years since we have recorded data (2007). It is assumed that the warmer winter temperatures, the late January thaw in the Libby area that caused ice damming and flooding on Flower Creek, and increased precipitation this year that resulted from multiple rain-on-snow events and higher than normal snowmelt for this time of year is the cause of the rising readings. It appears the runoff and rainfall events that have shown up in recent inflows have now routed through the reservoir and embankment and are now

present as higher piezometer readings and increasing outflows. With warmer temperatures expected over the next month, we anticipate increasing inflows and outflows through the dam. We expect that water levels will continue to rise before next month's inspection.

The graph above shows that the phreatic water surface has risen to levels higher than any BHI has on file for this time of year. This winter has had more warming and cooling temperature fluctuations than in the past 10 years. This has led to increased snowmelt before the typical runoff season occurs in April and May.

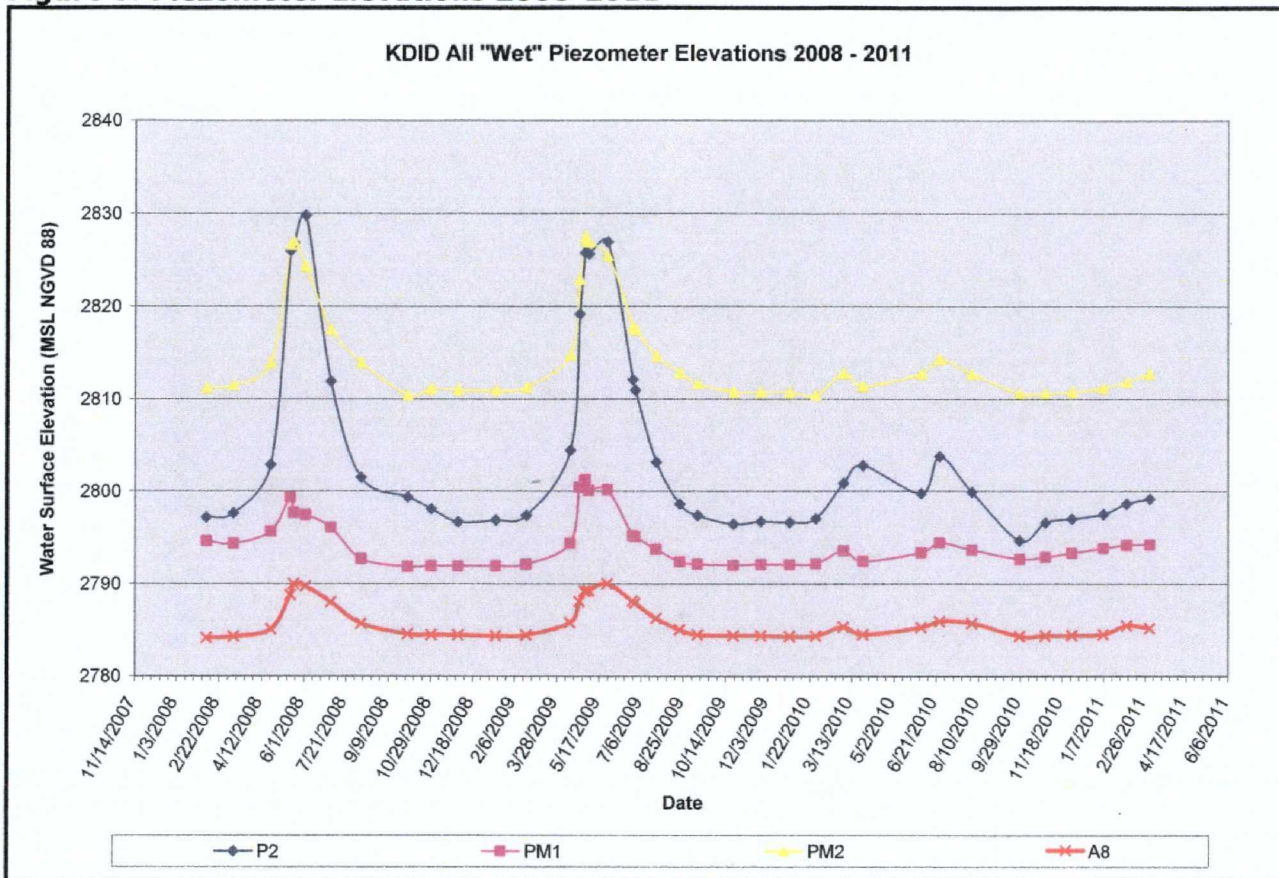
Figure 3: Piezometer Elevations 2008-2011

A second graph of the piezometers in Figure 3 below is a graph of the same piezometers as in Figure 2 above over a shorter period of time. The graph below represents the piezometer data collected since BHI began inspections onsite.

The graph above again shows a continued rise in piezometers P2, PM1 and PM2 as discussed above which also does not show up as pronounced in previous years at this time. This is, again, likely caused by higher snowpack levels and precipitation than we have seen since BHI began inspections.

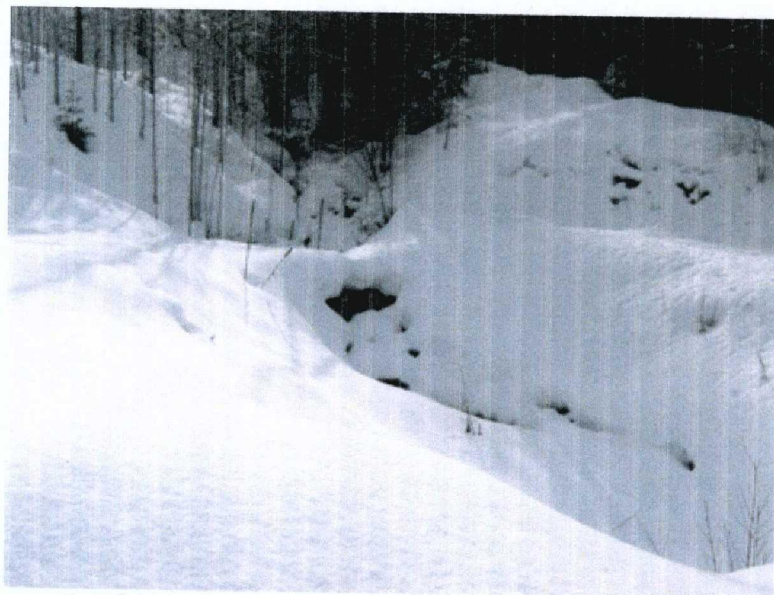
Looking Upstream to CC-02- Note Heavy Snow

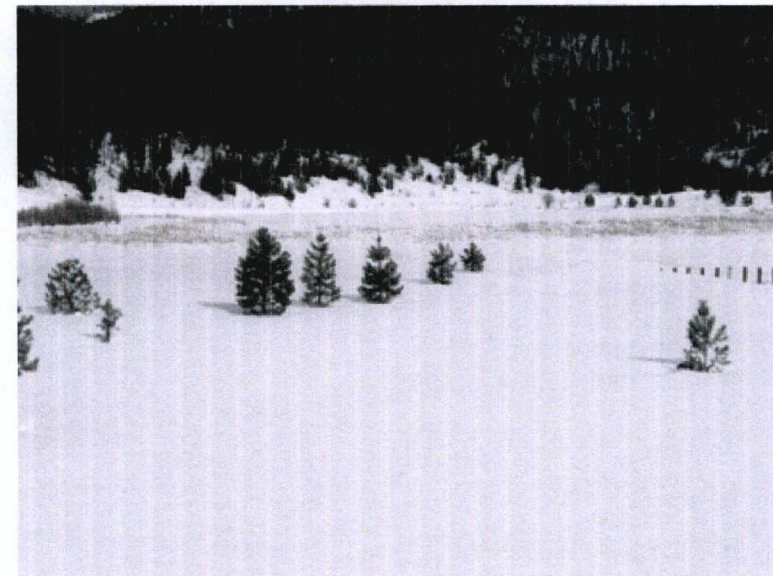
Heavy and drifted snow was observed near the trash rack during this month's inspection. Ice damming around the trash rack is possible this spring. Extra care will need to be taken to make sure the trash rack remains clear, weeds are removed from the entrance channel and the spillway is kept clean and clear of debris.

Heavy Snow near Trash Rack

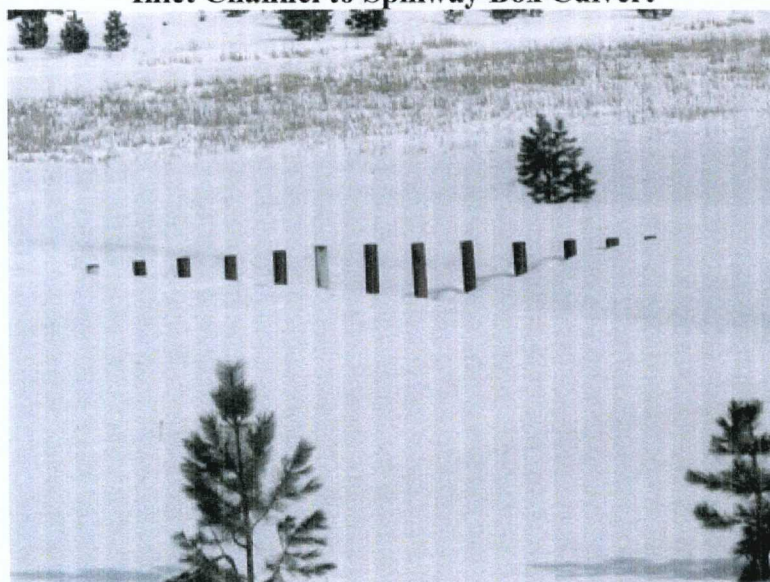
7. No water has run in the Spillway to date this year, but is expected this spring. No changes have been noted or observed and the trash rack is clean but there is heavy snow around it. Ice dams are possible at the trash rack this spring.

Trash Rack

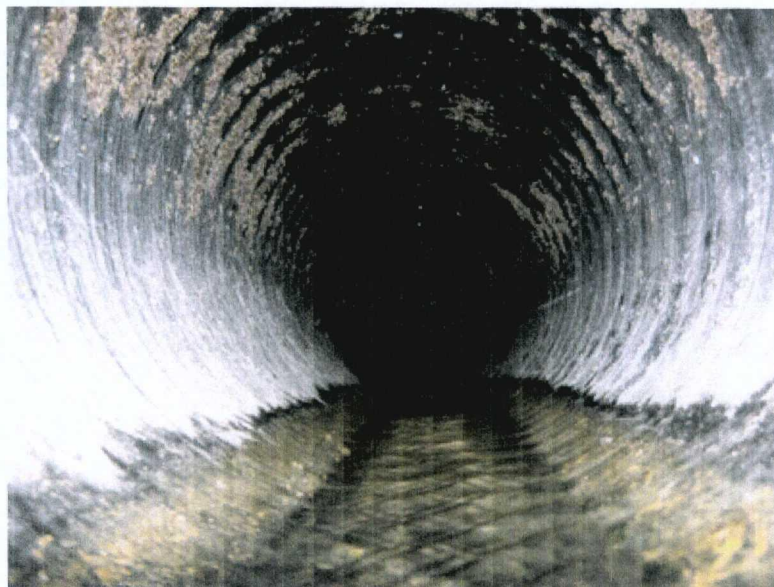
We are continuing to see flow from Drain 2. BHI has never seen water in Drain 2 during any prior winter inspection. Drain 2 does not typically run much after September and it does not typically start to run again until late may or June. We attribute this flow to the construction repairs made to the drain last year. It has been rumored that the spillway is one of the sources of water that causes Drain 1 and Drain 2 to flow. As we fully expect flows through the spillway this year we will monitor flows to determine if spillway flows affect Drain 1 and Drain 2 flows.

Inside Drain 2

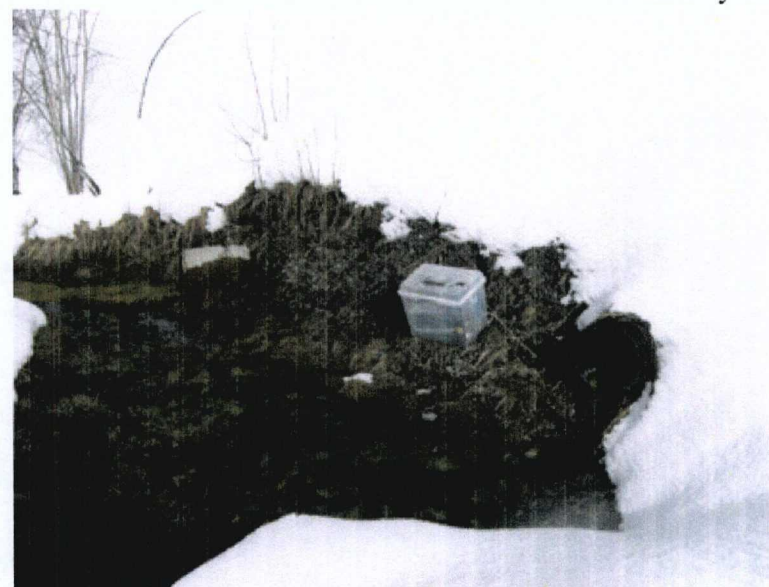
Snowmelt around Drain 3

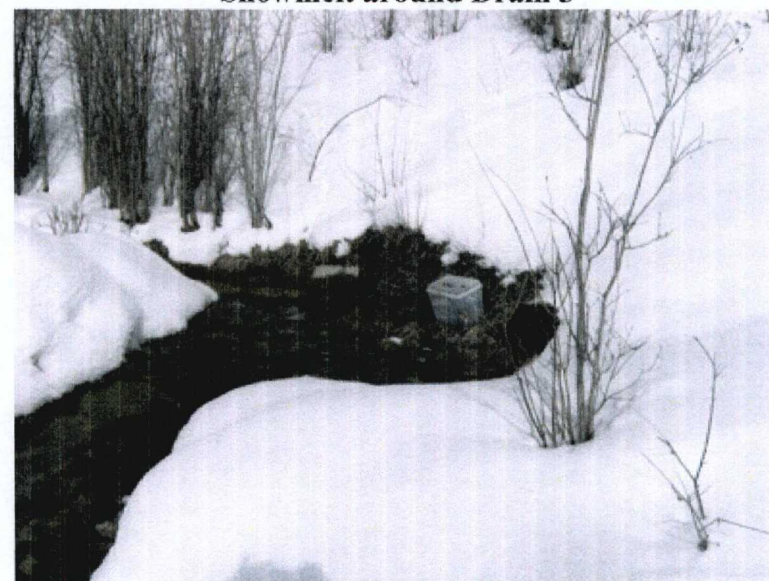
Snowmelt around Drains 3 and 4

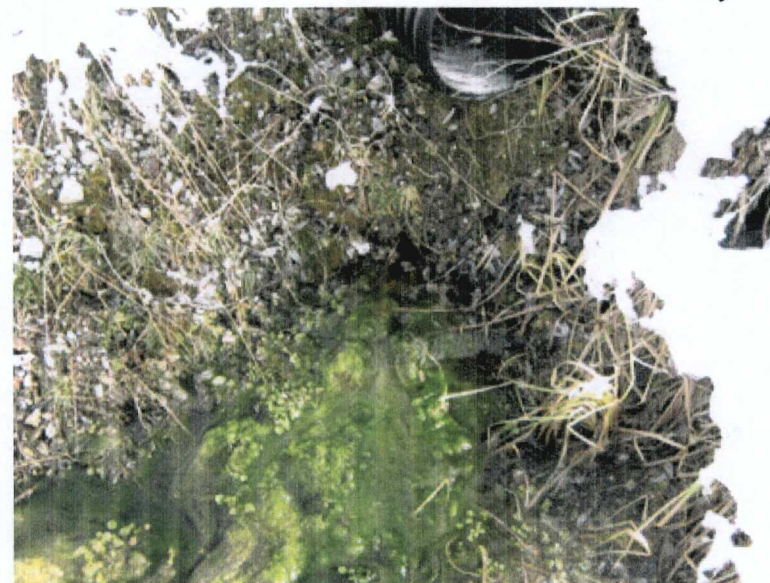
Seepage below Drain 7

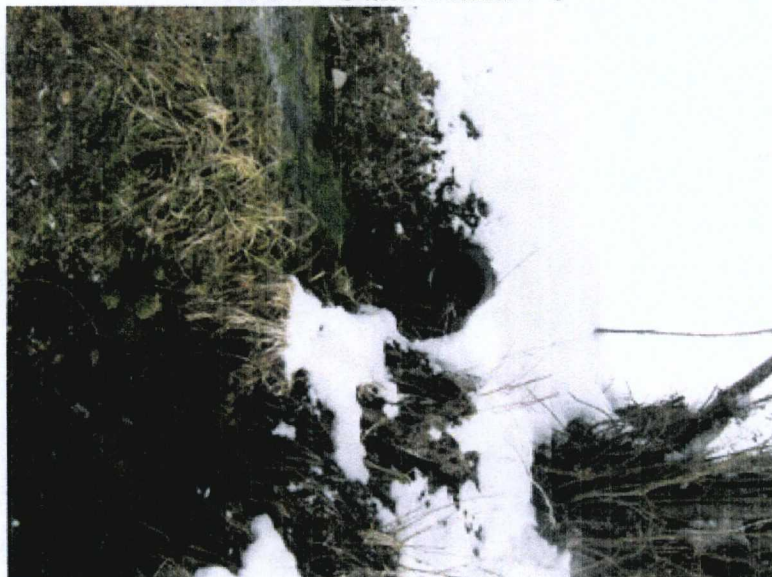
Snowmelt around Drain 7

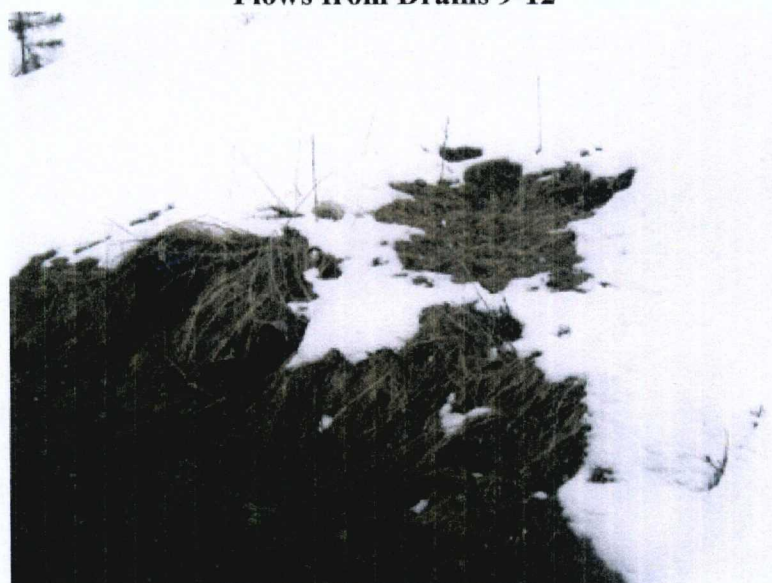
Snowmelt above Drain 11

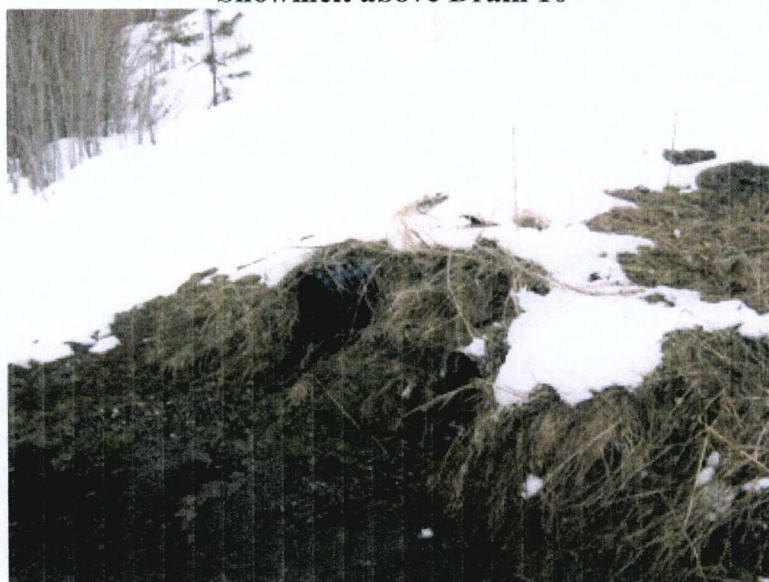
Snowmelt around Drains 10 and 11
